1. AGENCY USE ONLY (Leave blank)		2. REPORT DATE 8/19/96		3. REPORT TYPE AND DATES COVERED Final April, 1993 - March, 1996	
4. TITLE AND SUBTITLE OF REPORT Charge state of Ge-related point defects in oxidized SiGe Alloys				5. FUNDING NUMBERS G N0014-93-1-0777 G N0014-93-1-0777

Charge State of Ge-Related Point Defects in Oxidized SiGe Alloys

M.E. Zvanut, PI  
University of Alabama at Birmingham  
Birmingham, AL 35294-1170

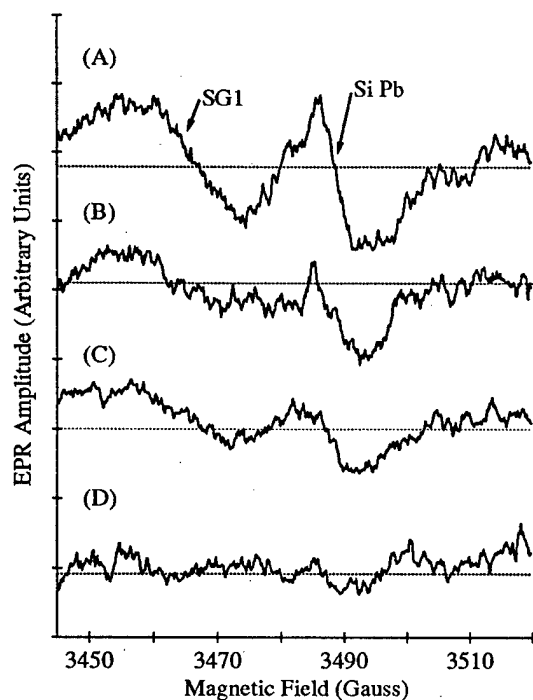
Figure 1. EPR spectra obtained after:  
 (A) growth of 40 nm anchor oxide  
 (B) 15 min KOH etch  
 (C) 20 min KOH and 2.75 min HF etch  
 (D) additional 90 min KOH etch

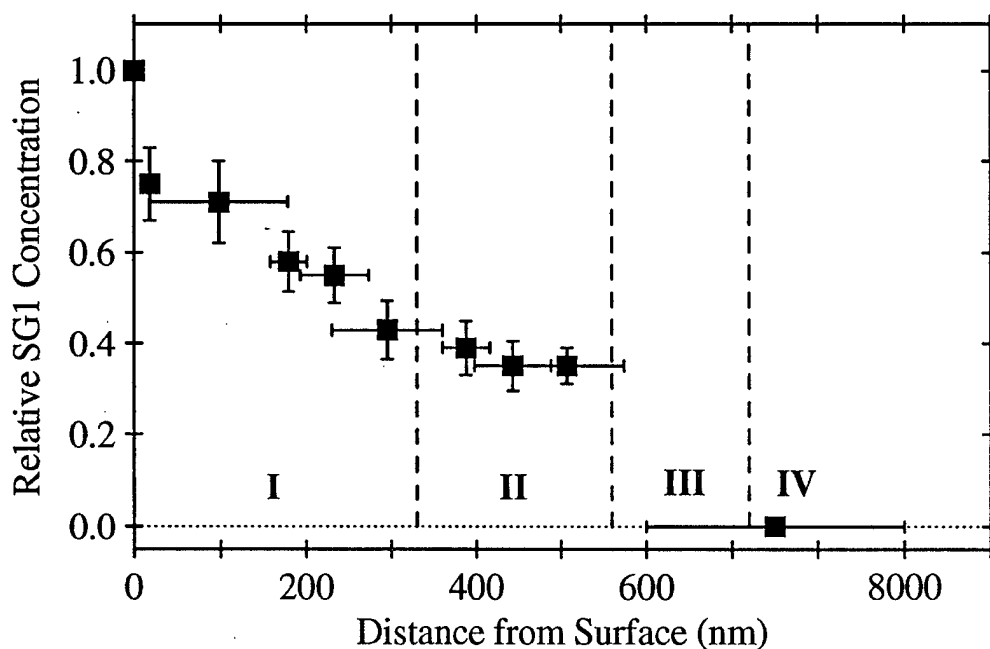
Figure 2. Depth profile for SG1 center; y-axis represents the original surface of the top SiGe layer. I, crystalline SiGe; II, buried oxide; III, damaged SiGe; IV, unimplanted SiGe
